# AZIMUTH MARINE SURVEY LLC

## SURVEY REPORT #103M25

**Vessel Name:** "XXXX X XXXXX"

**Builder:** Hatteras  
**Designer:** J. Hargrave  
**Year Built:** 1977  
**Model:** Hatteras 58 Fisherman  
**LOA:** 58' 04"  
**Beam:** 15' 10"  
**Draft:** 4' 09"  
**Displacement:** 63,000 Lbs.  
**Hull Type:** Modified Deep Vee  
**Material/Color:** Fiberglass / White

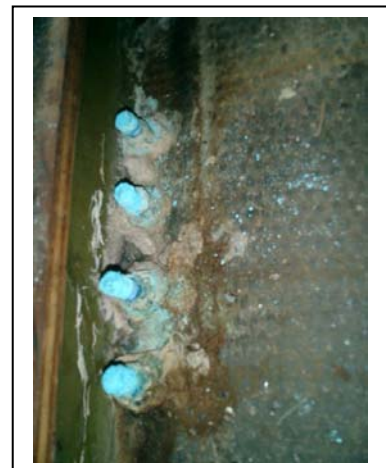
*port strut*

**Hot Water Heater:** "AO Smith" 19 Gallon - 220vac – operational, no apparent leaks  
**Bonding system / Condition:** Yes / many wires found corroded and broken at terminals, Transom strap broken,

heavy oxidation noted on shaft strut through bolts. The need for review and repair of system is indicated. (Note)

20. Batteries should be secured in their boxes so as to prohibit movement of greater than one inch in any direction (ABYC E 10.7.1 – 10.7.12).
21. Rewire fwd head sump pump. It is at present wired to the head dome light.
22. Repair/replace windshield wipers as necessary.
23. Repair and replace bonding wires and connections as necessary. Consider review of the entire system. There is still debate as to whether or not to bond a vessel. It is clear that if bonded, the system must be well maintained. A failing bonding system will much hasten the decline of a vessel's underwater bronze fittings.
  - Shaft strut through bolts show particularly heavy oxidation. Consideration should be given to pulling one or two of these bolts for closer evaluation of their overall condition at the next scheduled haul out.

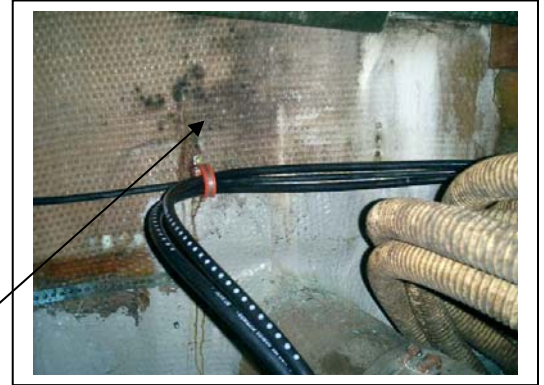
- Transom above both exhaust flanges moisture content 700 port and 750 stbd. Adjacent to the 2<sup>nd</sup> inboard from port swim platform bracket reading 630 relative. The core appears saturated in these areas. Further exploration and repairs should be considered.
- Foredeck above the anchor chain locker reading 200 (normal is approx 50) and 400 when measured from the underside of the deck. Core is deteriorated as seen at the spill pipe. Repairs should be considered.
- Stbd aft discharge at LWL percussion hammer indicates solid laminate, moisture content 530 relative. Further exploration should be considered.
- Anchor washdown pump supply thru hull stbd fwd. Hull is solid laminate, Reading 530 relative. Dead sound with percussion hammer.

7. Consider further exploration of transom core condition.
8. Suggest repairs to foredeck. Epoxy filling void around spill pipe will prevent further moisture intrusion.
